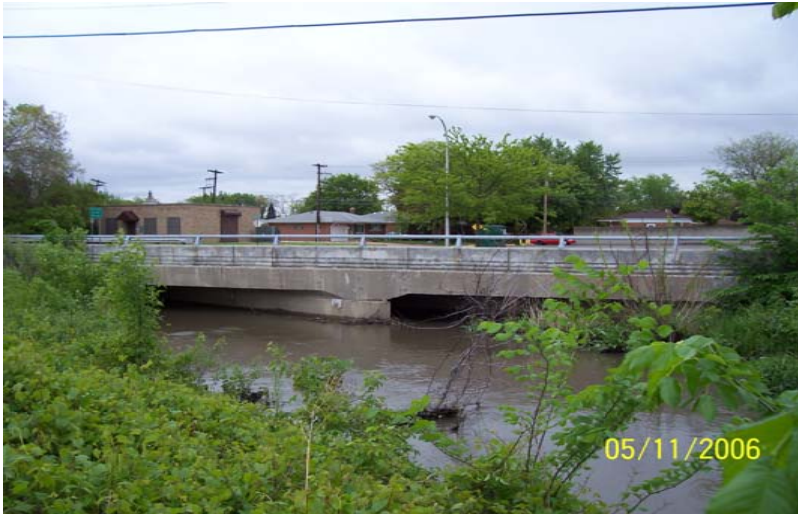
**1.1** Upstream face of Allen Road bridge from Thunderbowl Lanes bowling alley in Allen Park, looking downstream.

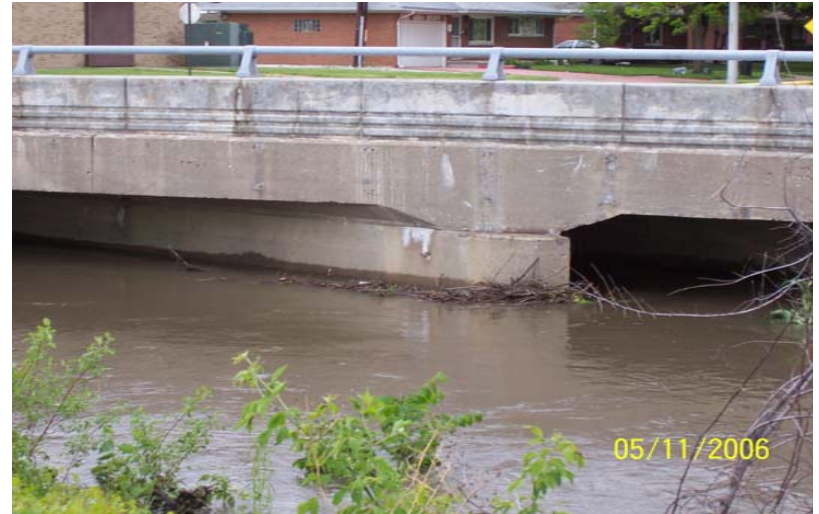
**1.2** Upstream face of Allen Road bridge in Allen Park, looking downstream. Note high water marks on bridge pier about six inches above flood levels.

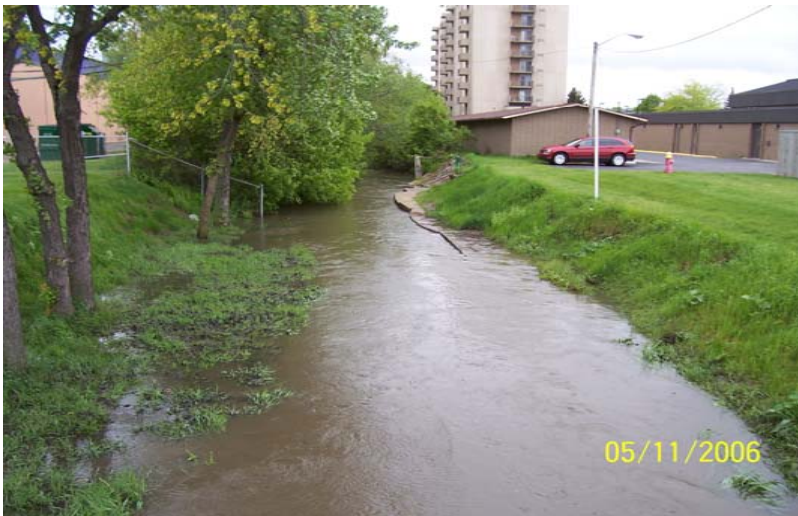
**1.3** NBECD from pedestrian foot bridge at Intercity Baptist Church property in Allen Park, looking downstream.

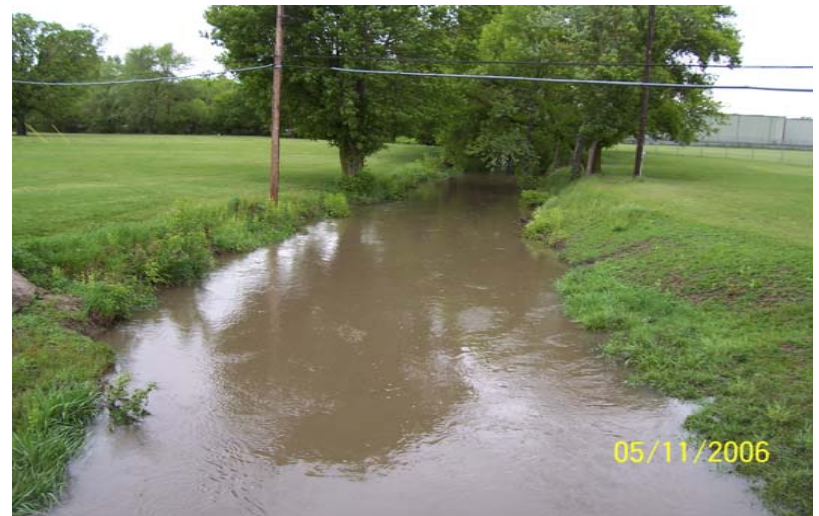
**1.4** NBECD from pedestrian foot bridge at Intercity Baptist Church property in Allen Park, looking upstream.

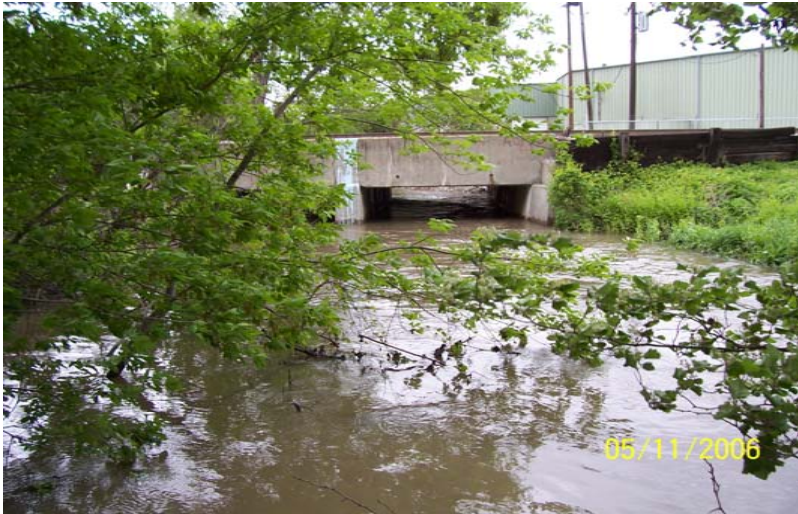
**2.1** Downstream face of railroad bridge crossing near confluence with Reek Drain in Allen Park, looking upstream.

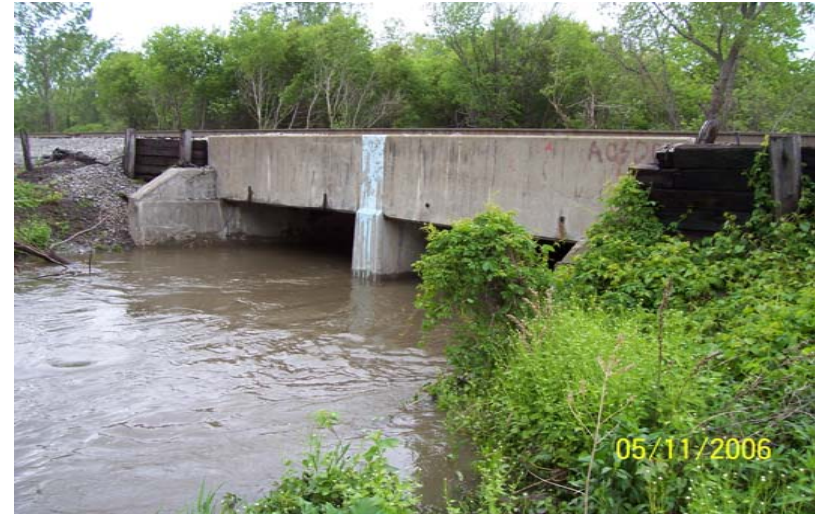
**2.2** Downstream face of railroad bridge crossing near confluence with Reek Drain in Allen Park, looking upstream.

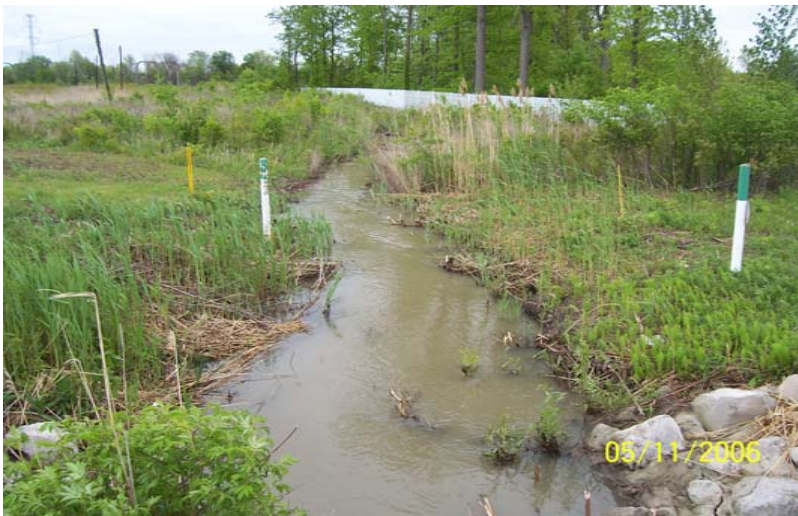
**2.3** Reek Drain east of Southfield Freeway behind commercial property in Allen Park, looking downstream. Note drain is near bank-full conditions.

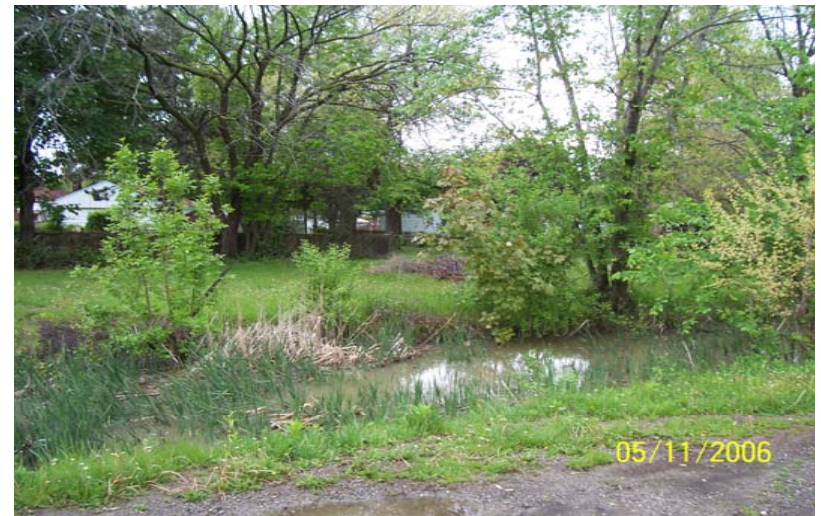
**2.4** Reek Drain through Cunningham Park in Allen Park, looking upstream. Note drain is near bank-full conditions and proximity of drain to nearby homes.

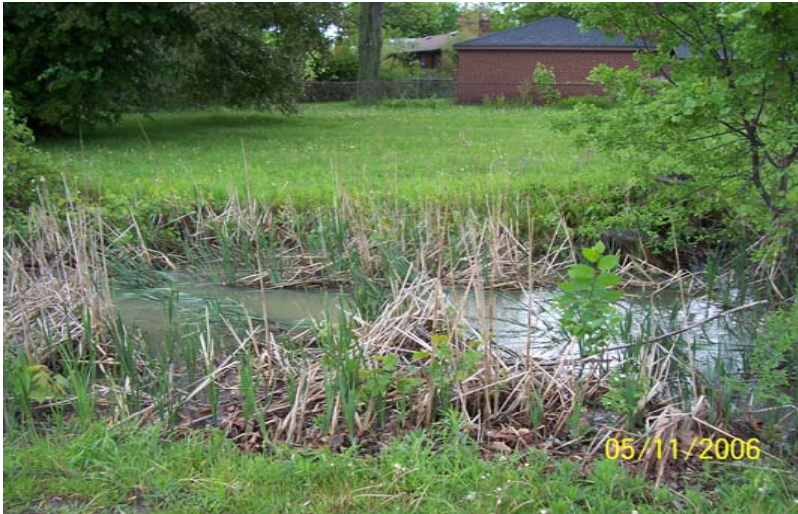
**3.1** Reeck Drain in Cunningham Park in Allen Park, looking downstream. Note heavy brush and vegetation present along overbanks and in main channel.

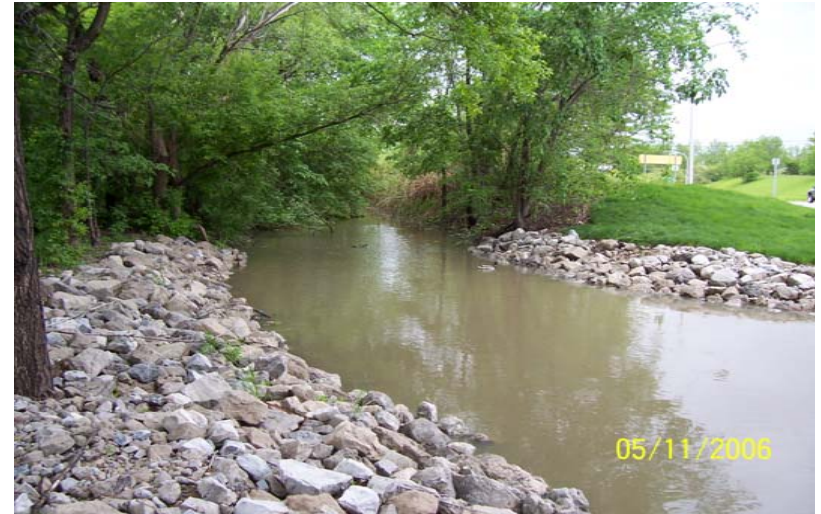
**3.2** Reeck Drain just east of Pelham Road in Allen Park, looking downstream. Note drain is near bank-full conditions.

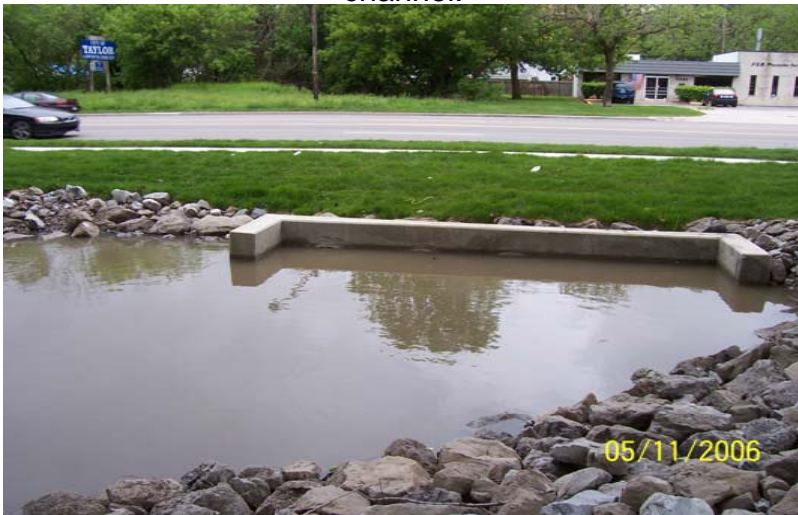
**3.3** Reeck Drain culvert under Pelham Road in Allen Park, looking upstream. Note flood level is about six inches below the top of headwall.

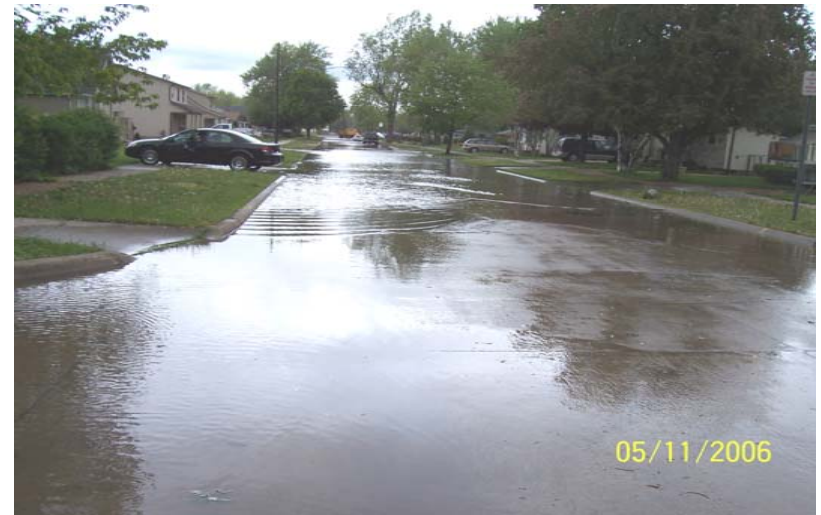
**3.4** Street flooding on Jackson Avenue south of Van Born Road and west of Pelham Road in Taylor, looking south. Note flooding near top of curbs.

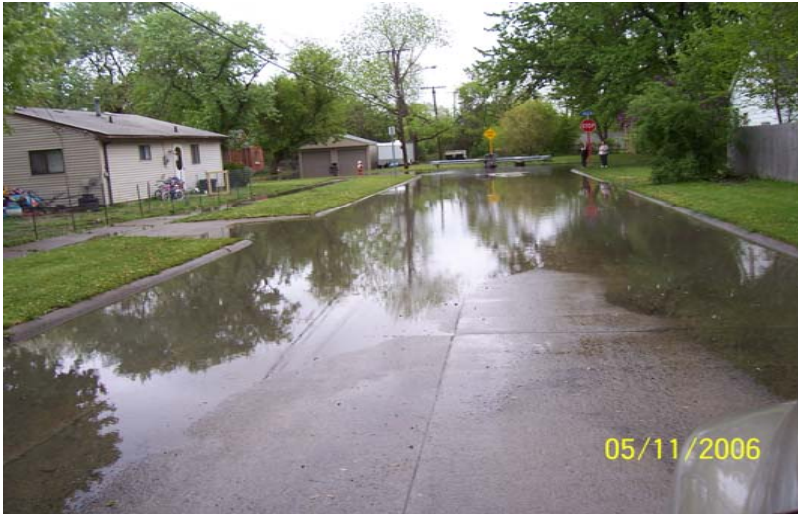
**4.1** Avalon Street near Jackson Street south of Van Born Road and west of Pelham Road in Taylor, looking east. Note flooding near top of curbs.

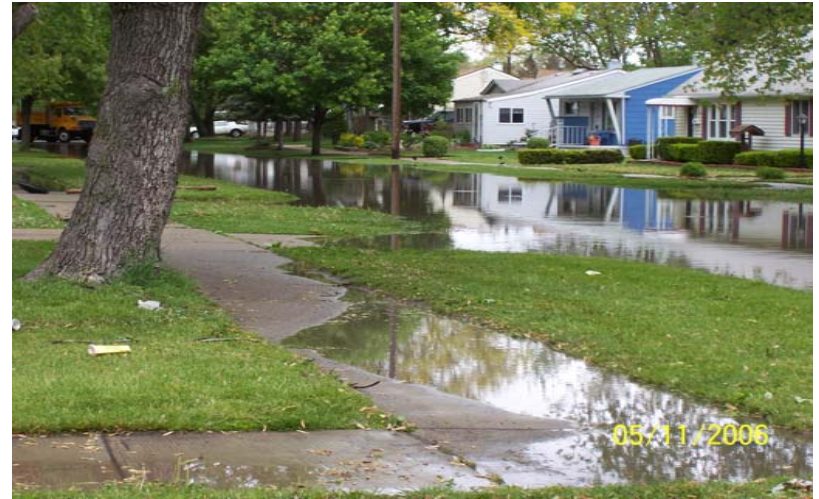
**4.1** Ziegler Street near intersection with Avalon Street south of Van Born Road and west of Pelham Road in Taylor, looking northeast. Note flooding is well above top of curbs and over sidewalks into front lawns.

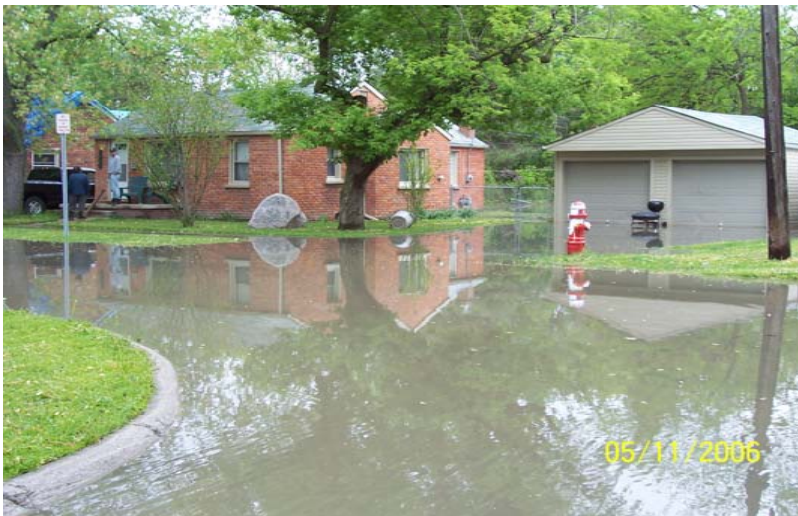
**4.1** Ziegler Road near intersection with Avalon Road south of Van Born Road and west of Pelham Road in Taylor, looking northeast. Note flooding over driveway and near brick ledge.

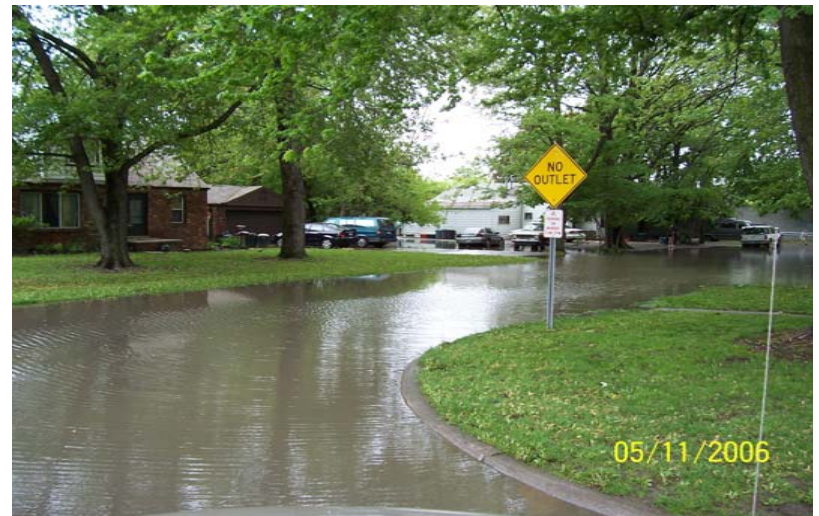
**4.4** Ziegler Road near intersection with Avalon Road south of Van Born Road and west of Pelham Road in Taylor, looking southeast. Note flooding into front lawns and over driveway.

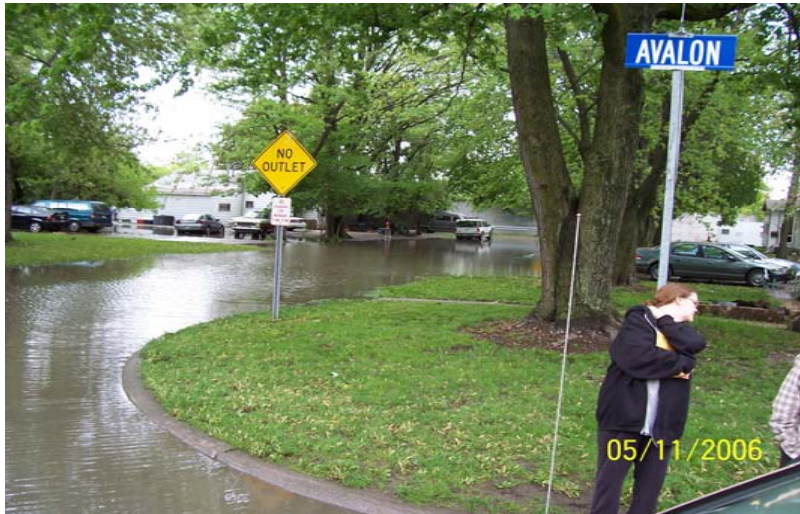
**5.1** Ziegler Road near intersection with Avalon Road south of Van Born Road and west of Pelham Road in Taylor, looking southeast. Note flooding into front lawns and over driveway.

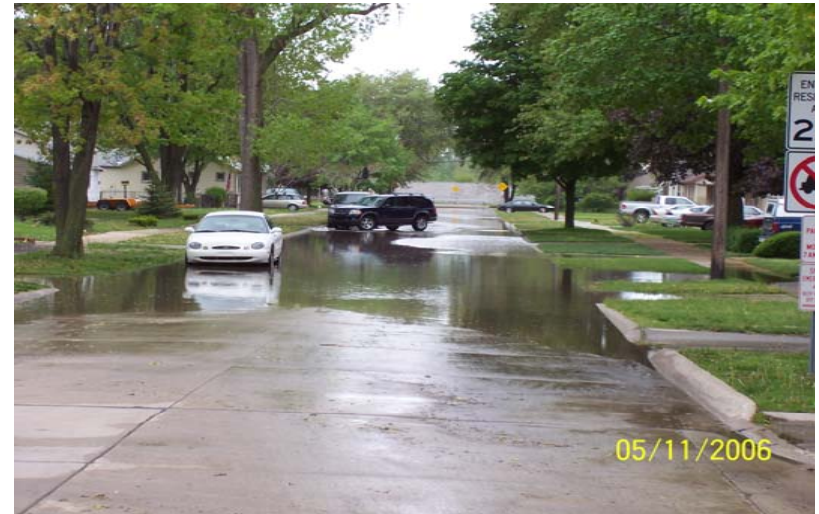
**5.2** Mayfair Street south of Van Born Road and west of Pelham Road in Taylor, looking south. Note flood levels near top of curbs.

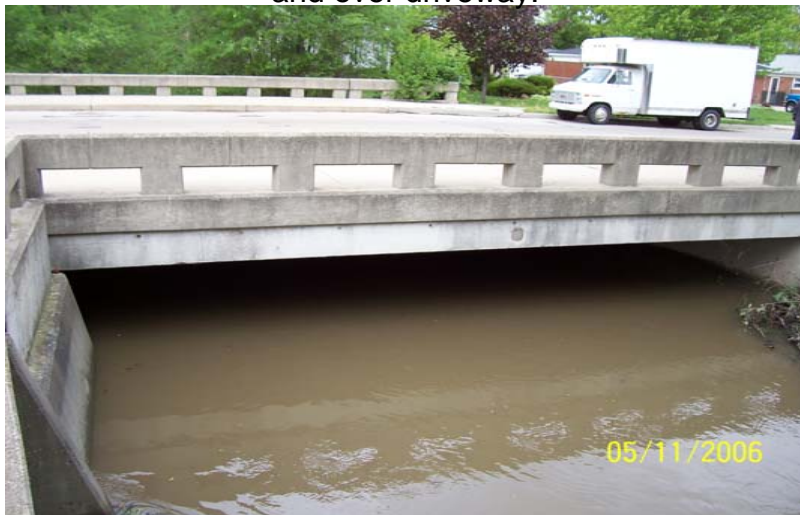
**5.3** Monroe Street bridge crossing over the NBECD in Dearborn Heights, looking upstream. Note flood levels were about one foot below low chord of bridge.

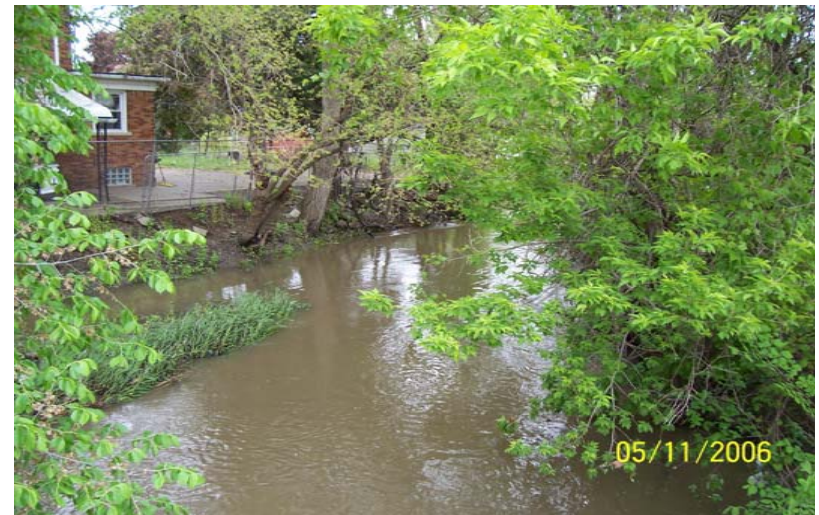
**5.4** NBECD near intersection of Monroe Street and Hanover Avenue in Dearborn Heights, looking downstream. Silt deposition observed about six inches above flood levels.

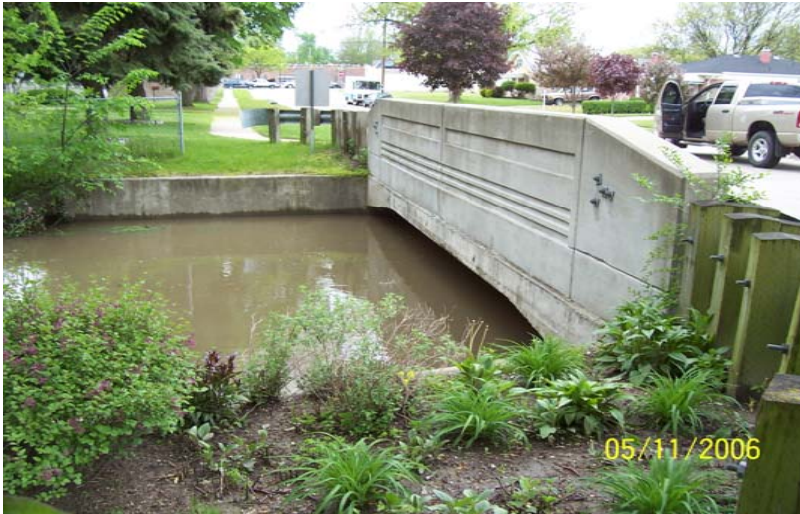
**6.1** Monroe Street bridge crossing over the NBEC D near Hanover Avenue in Dearborn Heights, looking south. High water marks on bridge abutments were about six inches higher than flood levels.

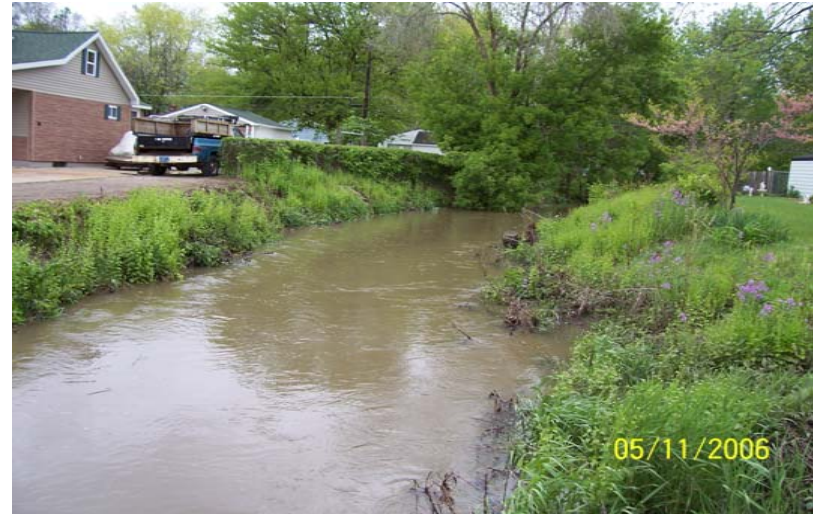
**6.2** NBEC D near Jackson Street in Dearborn Heights, looking south. High water marks on bridge abutments were about six inches higher than flood levels.

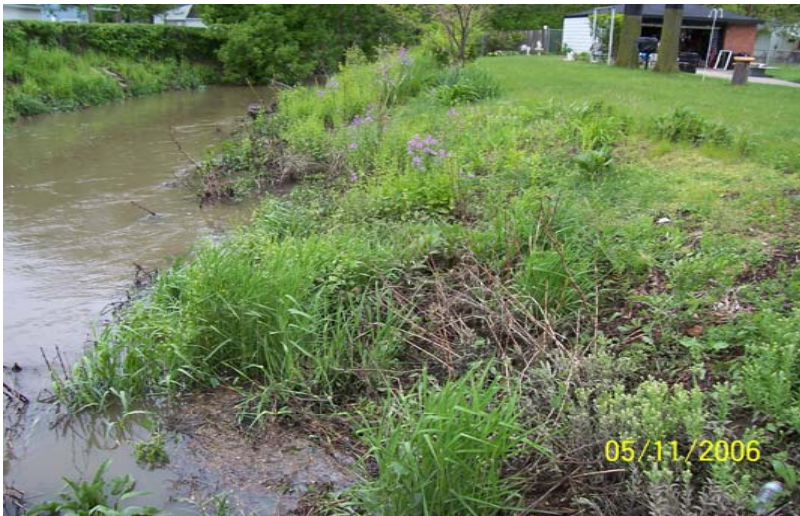
**6.3** NBEC D from Banner Street pedestrian foot bridge in Dearborn Heights, looking upstream. Silt deposition observed about six inches above flood levels.

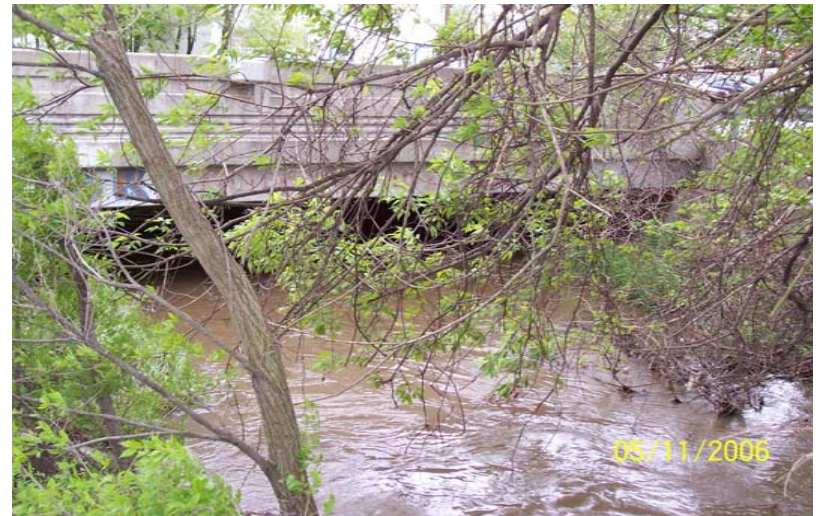
**6.4** Upstream face of Beech-Daly Road bridge crossing over the NBEC D in Dearborn Heights near USGS stream gage, looking downstream.
